FINAL REPORT
APRIL 1990

REPORT NO. EVT 17-90

COMPARISON OF STANDARD
ISSUE AND ANCRA
INTERNATIONAL MILVAN
RESTRAINT BEAMS IN STATIC
AND DYNAMIC ENVIRONMENTS

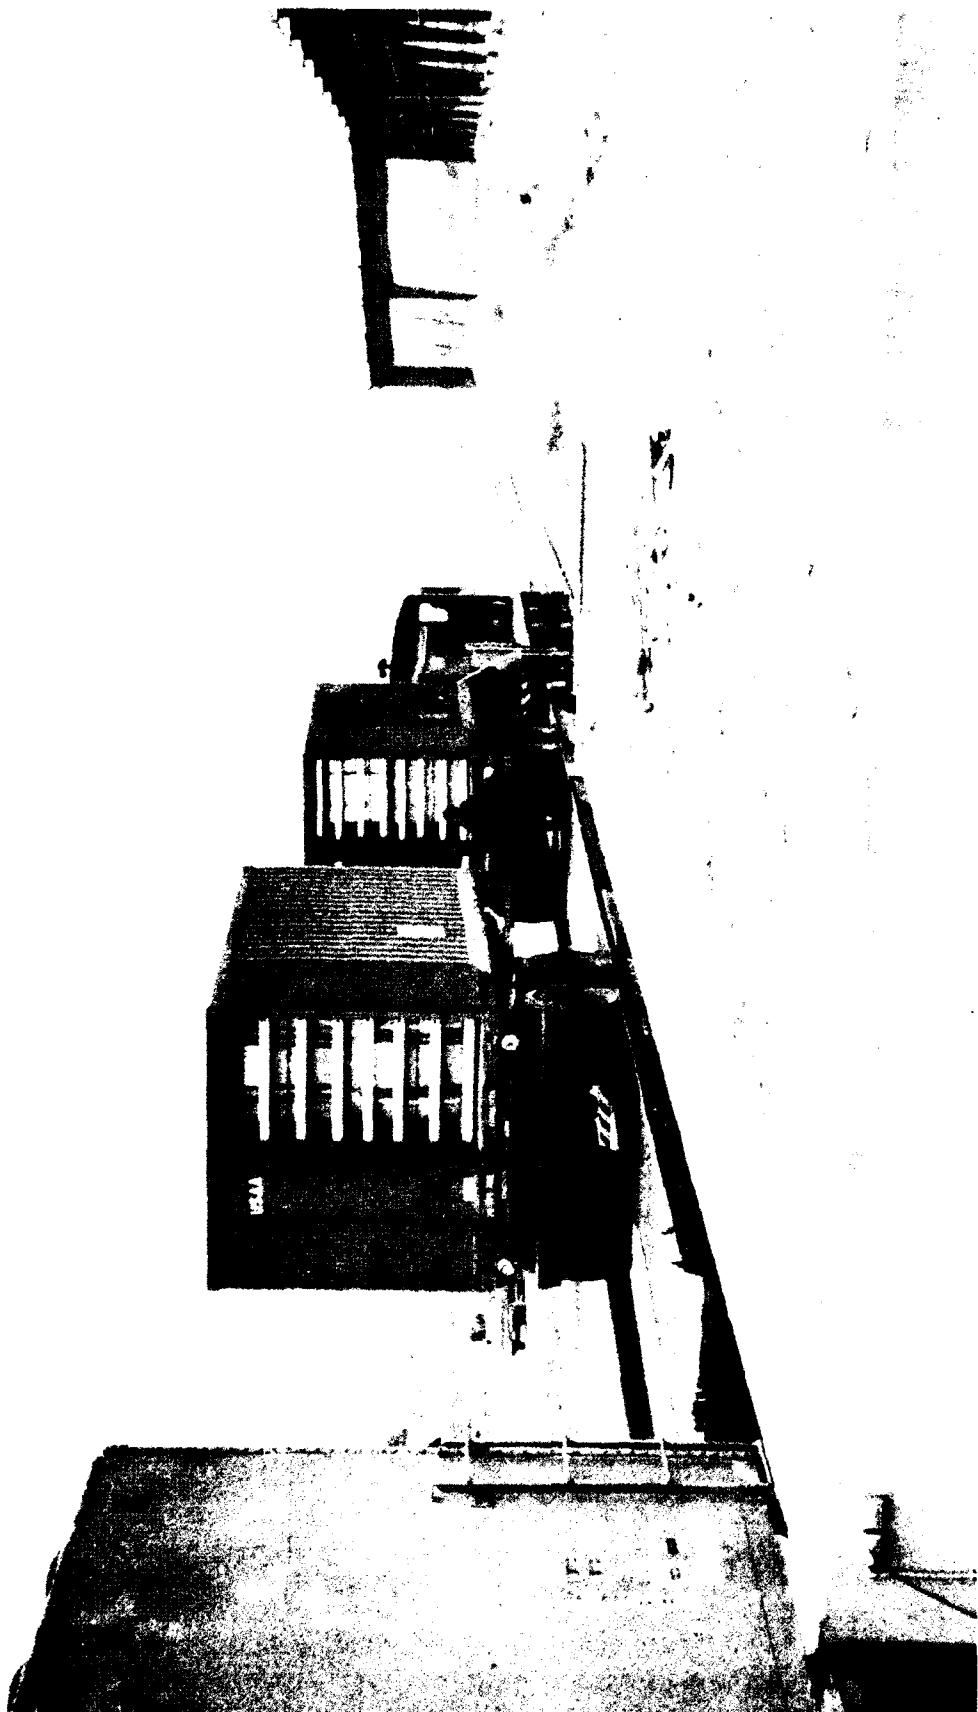
Photo No. A0317-SPN-90-230-3146. This photo shows two MILVANS loaded with inert boxed ammunition being tested for compatibility in the rail mode of transportation. One MILVAN has standard issue restraint beams, the other MILVAN has ANCRA International restraint beams.

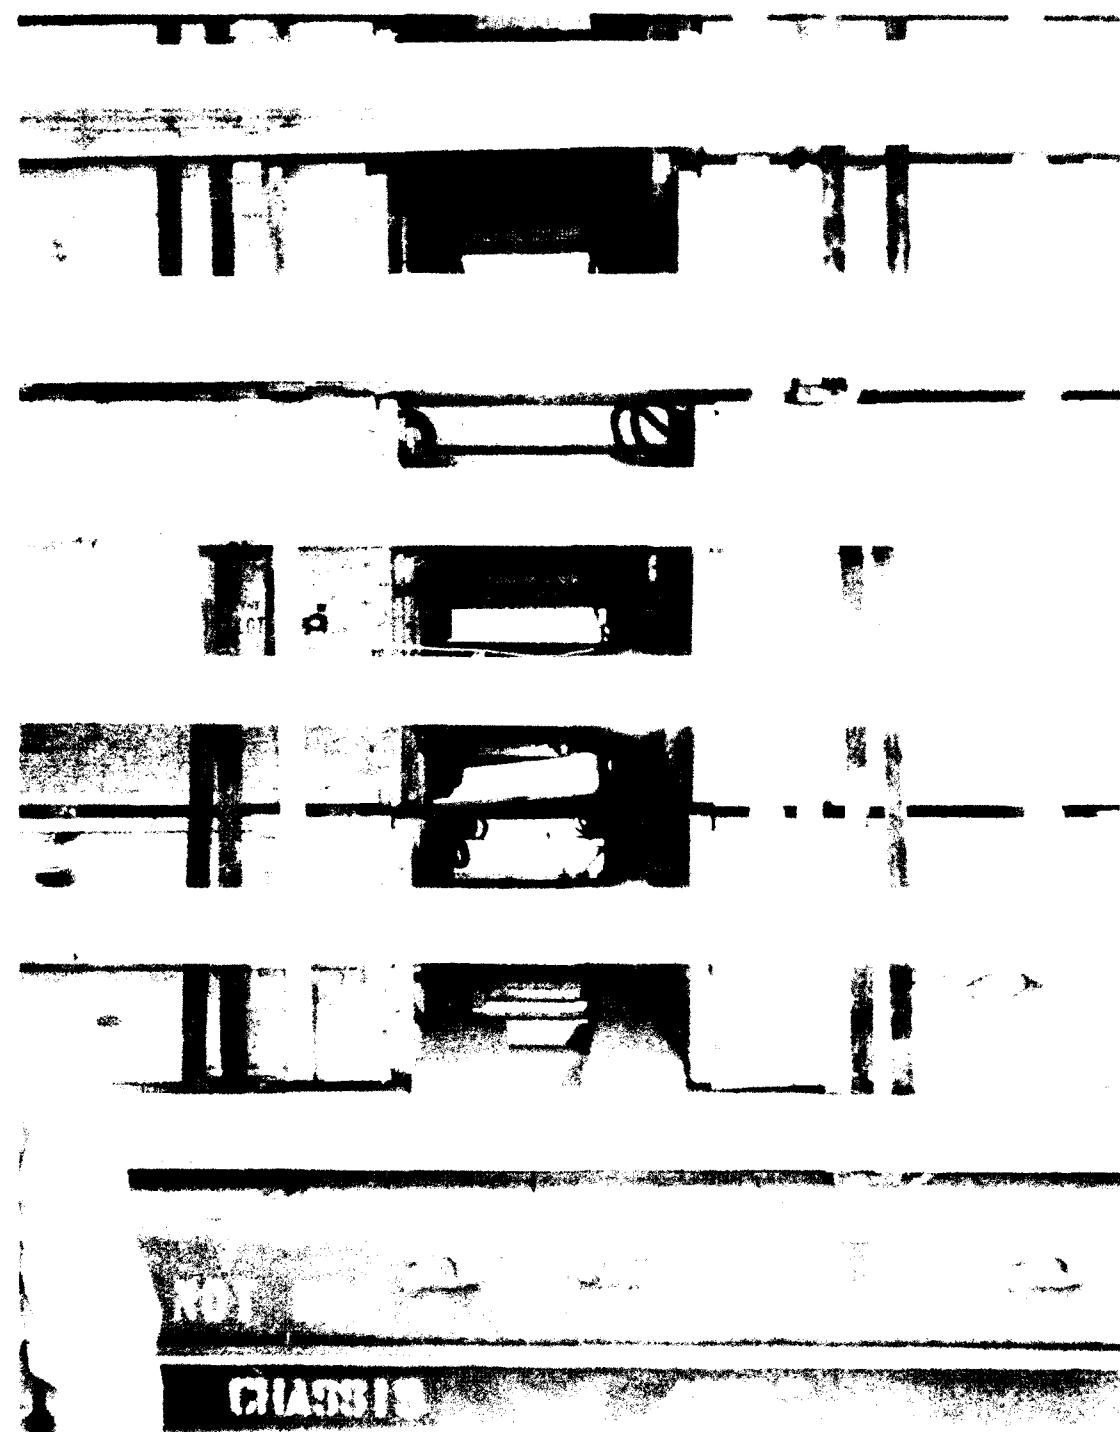
Photo No. A0317-SPN-90-230-3158. This photo shows the inside of the MILVAN restrained with ANCRA International restraint beams. Note one restraint beam is disengaged from the belt rail. Even though the one beam disengaged, no damage to the test load was experienced.

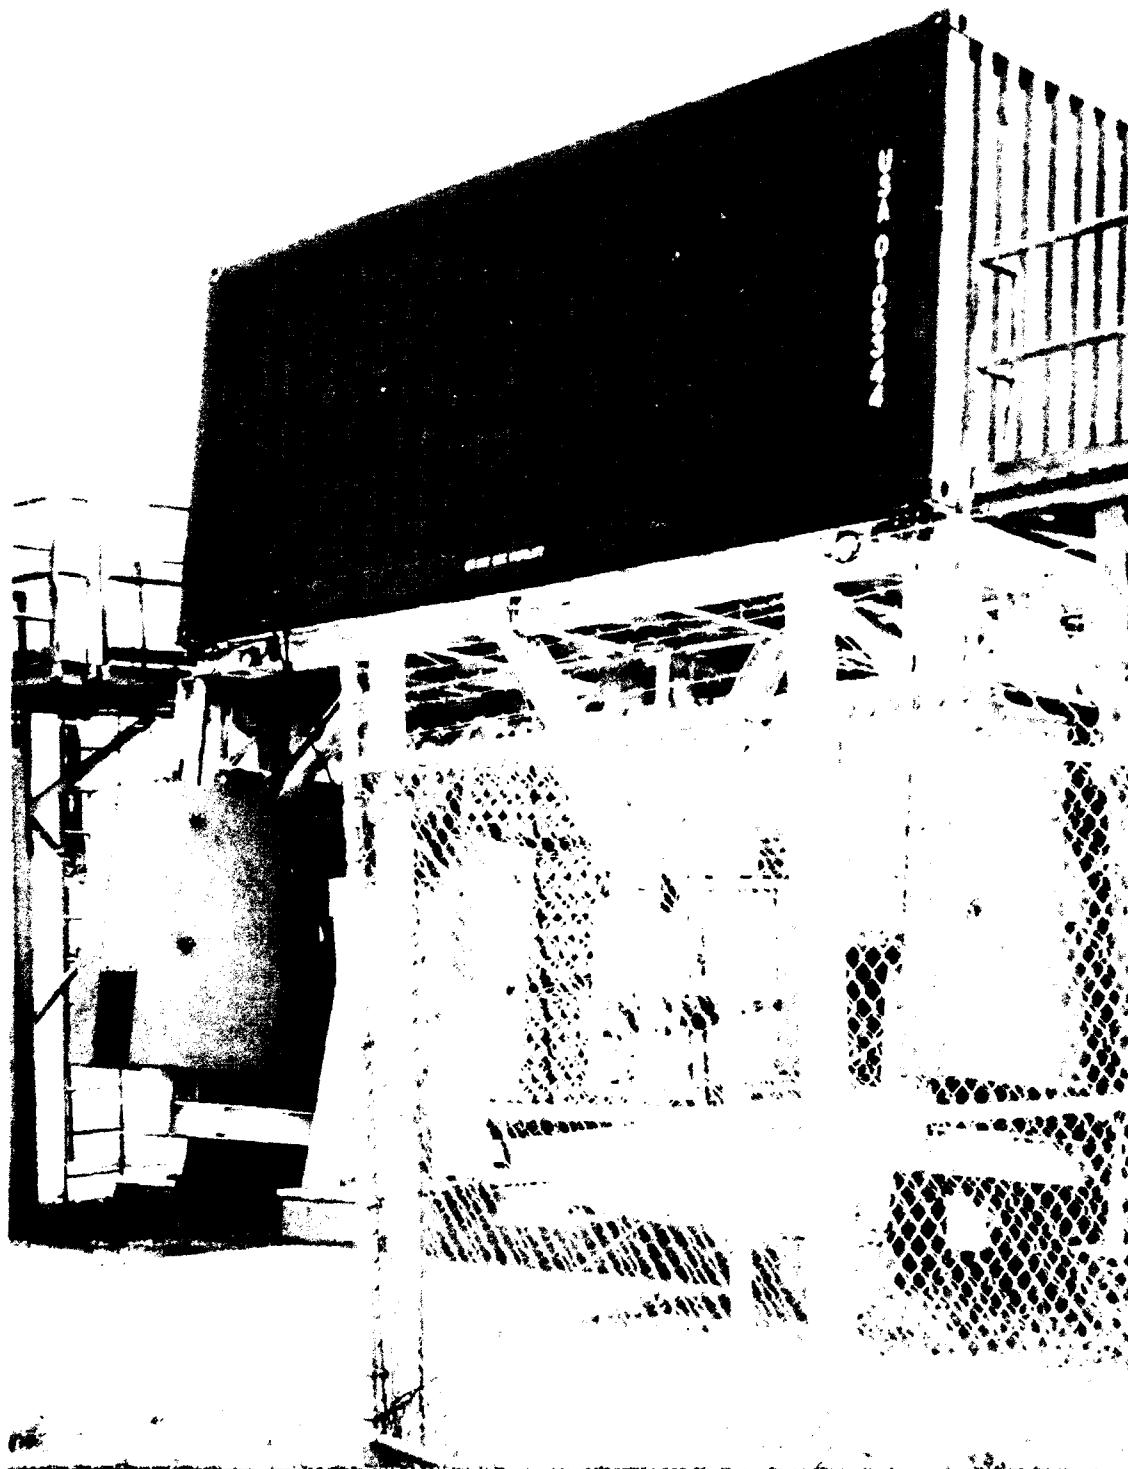
Photo No. A0317-SPN-90-230-3118. This photo shows one of the test MILVANs on the Shipboard Transportation Simulator (STS).
